Sealing Guideline (updated on Oct 13, 2015)

1. Introduction

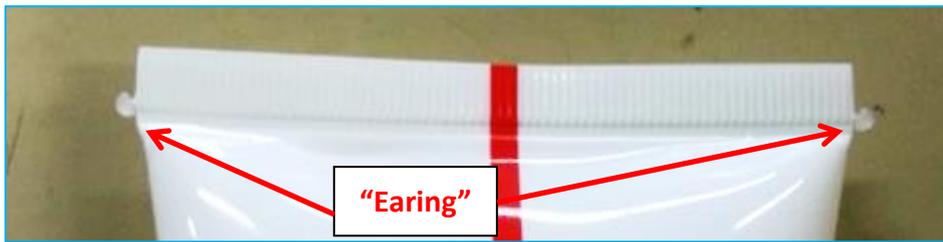
4.2 Earing

Problem: plastic residue on both sides or one side of the sealing line

Cause 1: clamping unit gap width is too tight thus squeezing and deforming the tube. If the earing appears only on one side, then the clamping unit is not parallel.

Cause 2: hot air temperature too high.

Recommendations: clamping unit can be adjusted by turning the screw at the top.

Recommendations: reduce the hot air temperature.

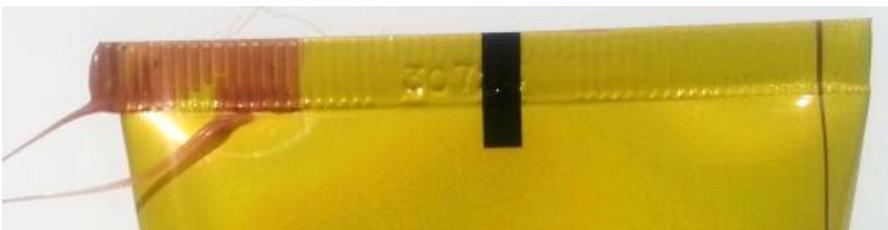
4.3 Residue material

Problem: residue material build up at the tube crimp area

Cause: nozzle head touches the tube inner surface because it is larger than the tube's inner diameter or nozzle head is not centered to the tube body (cooling ring too large, and not holding the tube centered). As the nozzle head melts the tube and consistently scrapes the inner wall of the tube, residue material builds-up on the nozzle and transfers the melted plastic onto the next tube, as shown on the photo.

Recommendations: reduce the diameter of the nozzle head to allow 1mm clearance, or the cooling ring so that the ring contacts the tube surface around the perimeter of the tube.

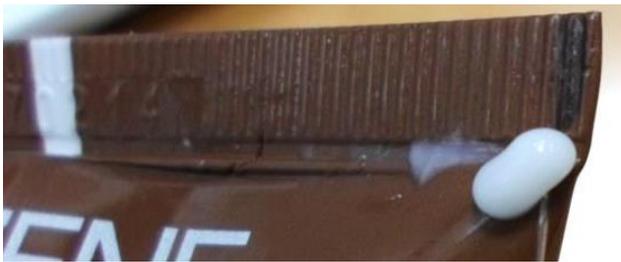
4.5 Leakage at tube seamline

Problem: seamline burst with possible product leaking out

Cause: tube sealed with label seamline too close to the tube edge. The folded edge is causing the label seamline to fold or bend, where the strength is compromised. The label seamline must be at least 5mm away from the tube edge to prevent folding.

Recommendations: adjust the eyemark to exact center

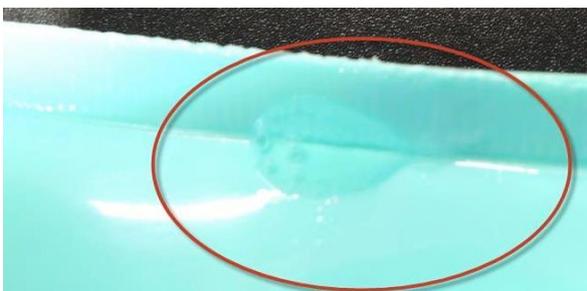
4.6 Leakage at tube sealing line

Problem: sealing line bursts and product leaking out

Cause: sealing line too thin thus weakening the sealing strength.

Recommendations: refer to 'Sealing Line Thickness' section.

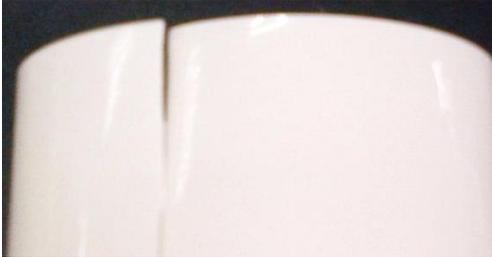
4.7 Tube seamline break before sealing

Problem: The label seamline breaks when fixing the tube in position before filling.

Cause: At the positioning unit, the conical part that pushes the tube into the cup is either too big, the pressure is too high, or the tube is positioned too high. The pressure from the cone pushes too hard on the tube, damaging the tube at the label seamline.

Recommendations: adjust conical part size or pressure, or adjust the height of the tube by lowering the turntable.
